EPA Compliance Evaluation Outfall Reconnaissance Inspection September 14, 2016

Compliance Evaluation Inspection: Village of Lawrence, MS4, Outfall ReconnaissanceInspection Date:EPA Representative(s):September 14, 2016Murray Lantner, P.E. Environmental Engineer, USEPA Region 2,

Attachment 3 – Lawrence, NY, Municipal Separate Sewer System
Outfall Inspection
September 14, 2016.

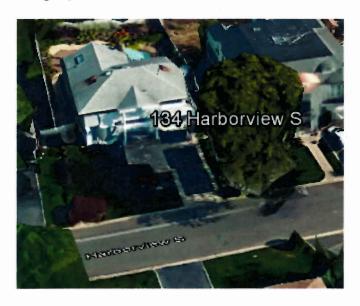
Part I.A.2 of the MS4 Permit only authorizes dechlorinated pool water discharges into the MS4. During the inspection EPA detected a chlorinated discharge of pool water into stormwater outfall 5 which is behind 45 Harborview West. The discharge was sampled using a Hach- Free Chlorine DPD kit, with a colorwheel (not an EPA approved method)

but a useful field screening tool. The discharge had a chlorine odor and a free chlorine concentration of about 3 mg/l. Chlorinated discharge was traced back to a house by following the trail of chlorinated water flowing down the street gutters to 134 Harborview South, where a pool cleaning truck belong to Advanced Swimming Pool Service (See photos 751 to 754) was parked. The chlorinated flow was seen entering a catch basin in front of 45 Harborview West which then flowed to SW Outfall No. 5. See aerial image below (the house has pool in the backyard). The Village of Lawrence representatives said that they contacted the pool cleaning service to explain the MS4 rules to them. Please provide EPA with the status of follow up with this pool cleaning company.

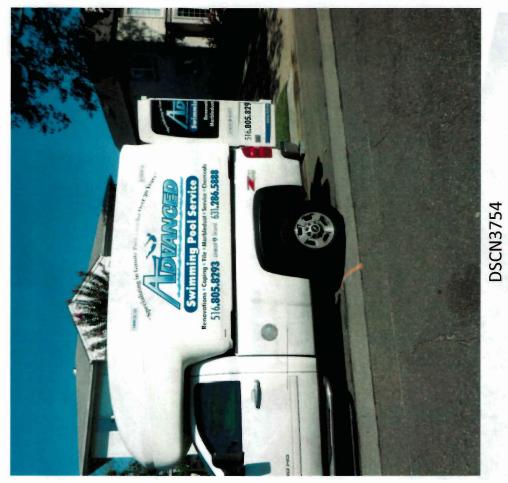
DSCN3751

40.60428	-73.7342	144	5	45 Harborvi ew West	Advanced Sy draining a p chlorine odor a free chlorine (unapprove	test kit with a ed method) of flow traced do	Service wharge had ine with a color who is mg/l a with who is mg/l a with street	was d a HACH heel nd	3	751 to 756	24	Potential Non- Compliance Advanced Swimming Pool Service parked in front of at 134 Harbor View South. Flow traced to SW catch basins on street. Municipal representative said that the Village does not alllow pool drainage into the MS4.

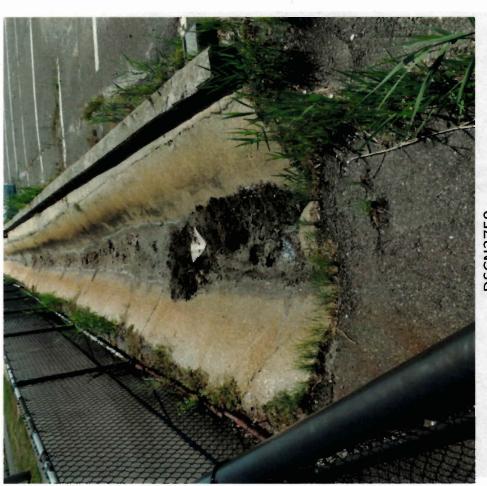
**DSCN3759**

- 1. As shown in photos 759 and 760 in attachment 3, the channel leading to stormwater outfall 17 (GPS point 148) there was sediment in the stormwater channel that was in need of cleaning. Village of representatives said that they would clean the sediment form the channel.
- 2. For the outfall labelled as 11A, GPS point 155, photo 764 was an unmapped outfall at the golf course. Please verify if this outfall is part of the MS4 or a non MS4 outfall.

40.60233	-73.7311	148	17	Channel at Marina	No Discharg	No Discharge but sediment buildup in channel 759,				, 760	Area of Concern - Channel Needs Cleaning
